Recovery of Collapse and Restoration of Tunnel Belonging to the Water Supply System

ABSTRACT: Underground structures require maintenance services and, if necessary, recovery, since they may suffer structural damage both during its construction as during its lifetime, by natural wear and tear or for associated geological-geotechnical risks. This article presents the measures adopted for recovery of collapse and tunnel restoration, executed by NATM method, located in the city of Mogi das Cruzes and belonging to the water supply system of São Paulo City, Brazil. We also present local geological aspects, diagnosis of rupture occurred, inspections and mapping of excerpts to be strengthened, short, medium and long term measures to be adopted and geological-geotechnical risks after recovery of the collapse.

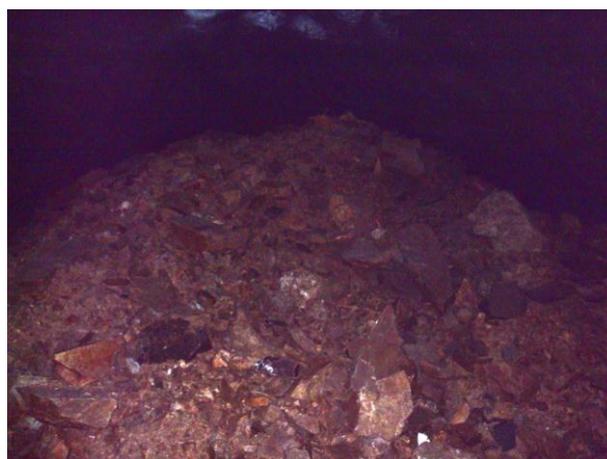
10 years, when its obstruction occurred by breaking effect in the vicinity of progressive 1,400 m, from the upstream portal. Figure 1 shows an overview of rupture. The rupture was observed from the flow reduction to 2m³/s.

Figure 1. Overview of collapsed section.

The original excavation section had no coat, and shotcrete was used to cover any flaws. The constant detonations led to formation of micro-cracks that evolved to more severe damage because of repeated blasting.

The following activities were provided for recovery of the collapse: 1) excavation of the rubble from the tunnel collapse, 2) Removal of loosen rocks in the chapel formed by collapse, 3) Implementation of trellis ribs every 60 cm (or less) and welded screen, 4) Application of shotcrete lining in tunnel Cap, 5) Implementation of inverted arch in shotcrete or reinforcement of cap base with injected root pile and 6) filling of chapel with mortar injection.

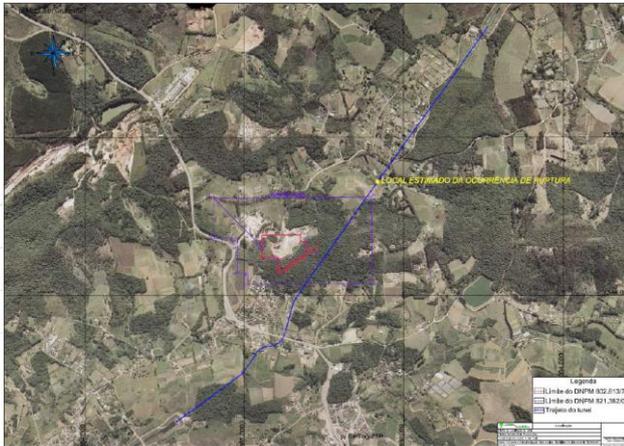
Figure 2 presents a general plan with the rupture location. Notice that on the left of the tunnel on the treeless area lies a quarry that was inactive during construction and began to be

explored just prior to the occurrence of the rupture.

Figure 2. General photo identifying the rupture site.

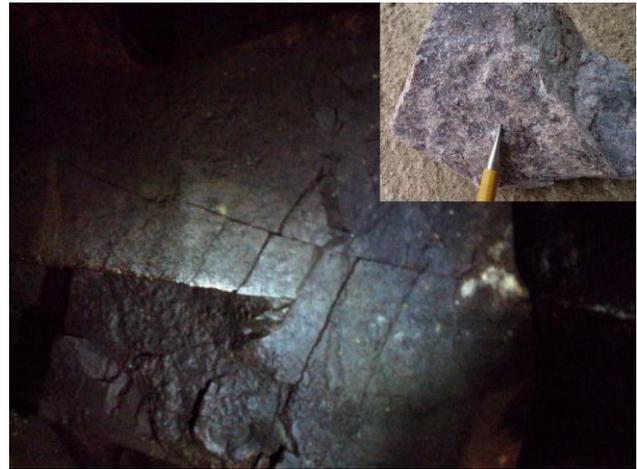
The rupture site matches approximately the geological contact between the granite and gneiss. It is a fragmented granitic, altered, oxidized and discolored (Figure 3). The sizes of the blocks that make up the rubble of the rupture indicate spacing between fractures about 20 cm. It was not observed contribution of groundwater at the rupture site.

Figure 3. Fracture system in wall of Tunnel 2 with detail of fragmented granitic quartz.

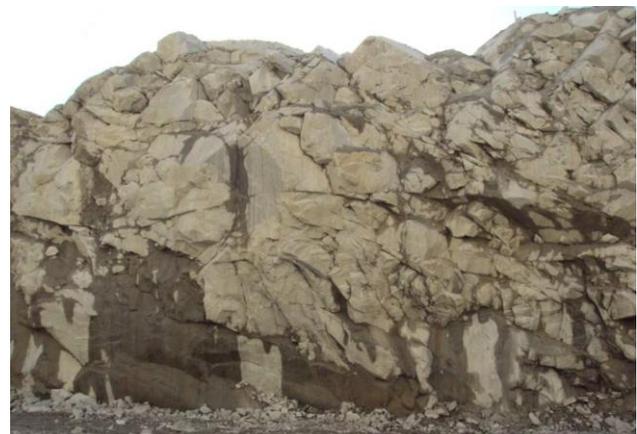
In the case of quarry close, repeated blasting lead to vibrations that by reaching the tunnel surrounding, generate micro-cracks and minor damage, leading to more severe damage by cumulative effect of repeated blasting. There were indications that the detonations from the quarry were of medium to high intensity, by the result on the quarry walls, showing intense fracturing of the rock massif, Figure 4.

Figure 4. Intense fracturing of rock ,mass on the quarry wall.

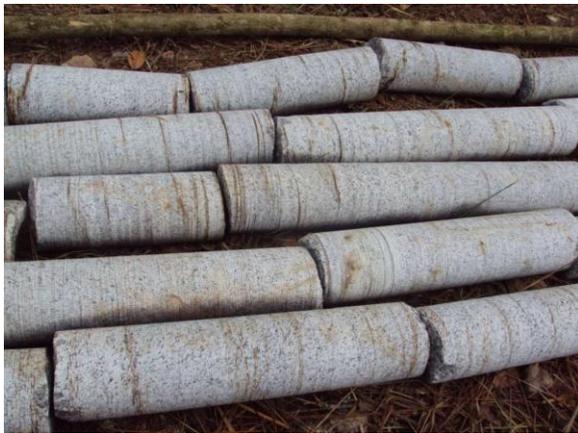
In addition to this observation, it has been found through probing hole performed nearby the rupture that the rock block on site features good geomechanical quality (Figure 5), and that it would not break spontaneously after over 10 years of good operation.

Figure 5. Rock block with good geomechanical quality nearby the rupture.

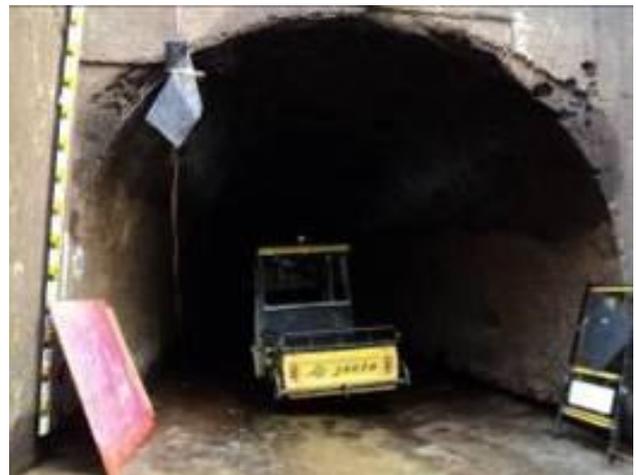
The tunnel intake portal section features horseshoe-shaped section portal with H and W \approx 3.8m. It was verified the existence of support system with ribs until the initial 370 m of the tunnel. This section showed overall good conservation condition, presenting only punctual degradations, possibly by effect of blasts after the construction. Figure 13 shows the view of the tunnel portal.

Figure 13. View of Tunnel 2 portal

We identified 15 sections requiring reinforcement in the support system, according to Table 1. The problems of these sites are related to supply of groundwater, and/or section loss, and/or fracture observed during qualitative visual inspections.

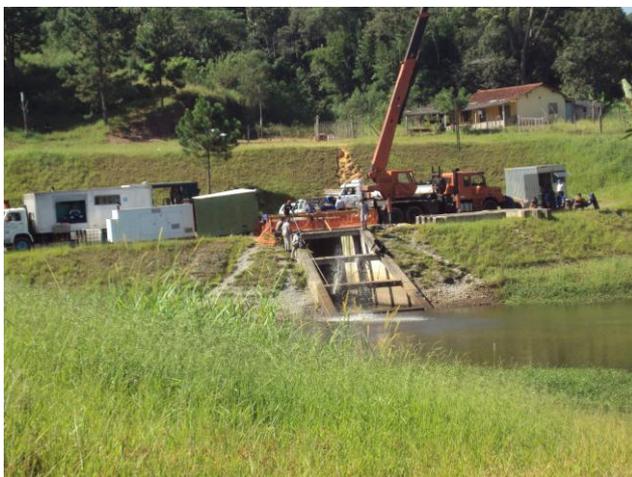
The tunnel features horseshoe-shaped section, com H and L ≈ 3.8m. There are some sections with ribs, which are: 0-150 (tunnel portal), 890-940 and 1030-1100m. Figure 14 shows a view of the tunnel outflow.

Figure 14. View of Tunnel 2 Outflow.

We identified seven sites requiring reinforcement in the support system, according to Table 2. The problems of these sites are related to underground water supply, and/or the section loss of the excavation. In the massif outcrop locations, with the exception of the rupture site, it is consistent and little to medium fractured, with visible drilling marks.
